## Kriminalistický a expertízny ústav Policajného zboru

# EXPERT TESTIMONY

ENG: PPZ-KEU-BA-EXP-2020/1507

**In case:** damage to hanging carabiners used in paragliding - air  
event SK12020001 of 01/01 2020.

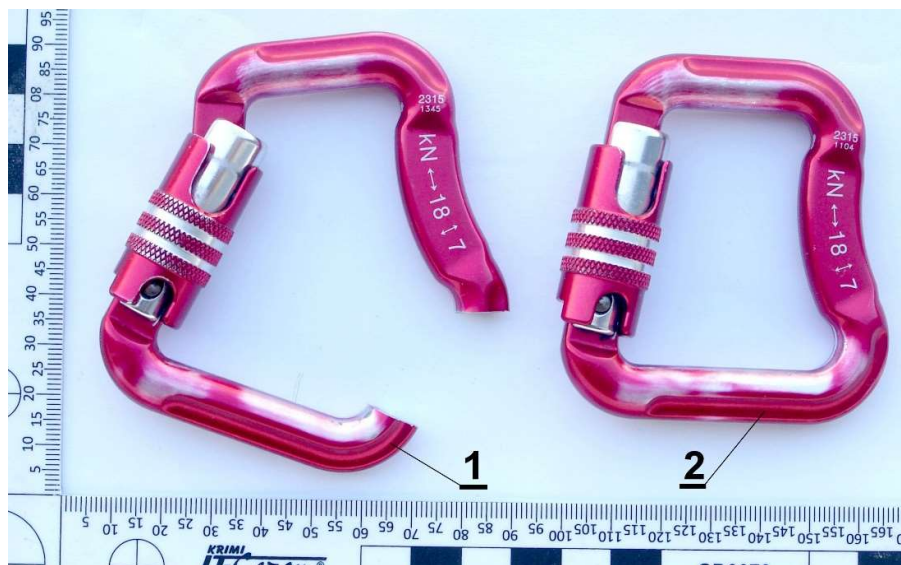
In order to ascertain the facts that had to be known in order to answer the questions given in the expert assessment order, the above mentioned carabiners, presented as piece n°1 and n°2 (photo n°1), were examined.

Photo n°1: Woody Valley CAMP carabiners presented as piece n°1 & n°2

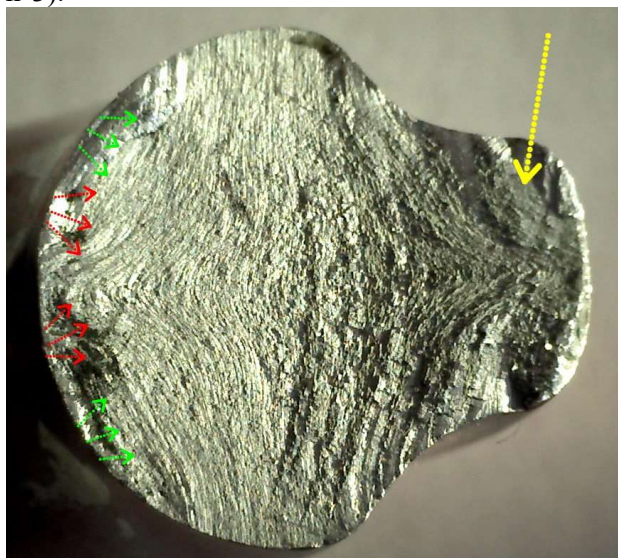
Carabiner n°1 was broken just above the bottom bend. It was a fatigue fracture with four initiation regions (see unusual lines of the fracture propagation strips and the resulting four initiation regions and initial fracture propagation directions marked with red and green arrows in photo n°2), as well as the clearly profiled area of the final fracture of the material (indicated by a yellow arrow in photo n°2). The location of the crack initiation areas corresponded precisely to the slight longitudinal surface protrusions at the bottom of the carabiner at the pressure point of the carabiner harnesses (quasi-edges marked by pink dashed line on photo n°3).

Photo n°2 : Fracture surface with clearly visible progression zones of crack propagation, with clear initiation areas as well as clearly visible area of final material breaking

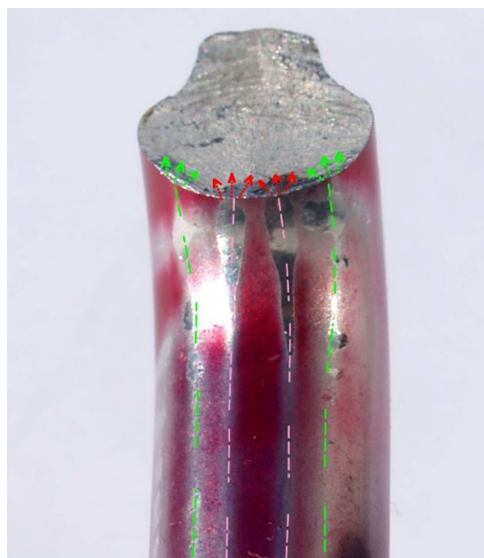
Photo n°3 : Direct positional correspondence between the fracture initiation areas and the longitudinal protrusions on the supporting working surface of the carabiner

As mentioned above, the fatigue fracture initiation points corresponded to the respective longitudinal protrusions at the point of pressure of the harness straps on the respective support working surface of the carabiner. Thus, in addition to the proven combined tensile-bending stress in the damaged carabiner cross-section, an additional compressive load was applied to the surface of the carabiner, which manifested itself in the position of fracture initiation points, but was not decisive from the material fatigue mechanism. (If the longitudinal protrusions were not present on the contact surface between the straps and the carabiner and the contact surface was smooth and smoothly rounded, the fracture initiation point would probably be only one and the progressive fracture propagation strips would have a slightly different shape).

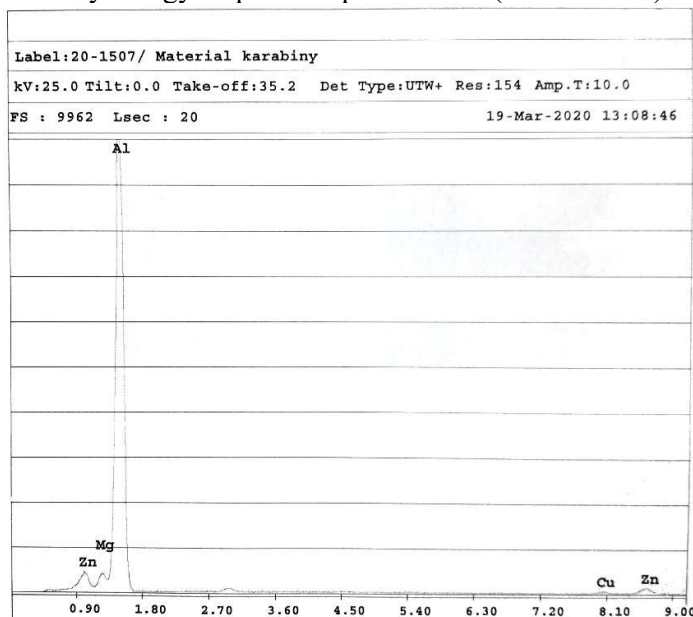
Spectrogram n°1 : Basic material of a damaged carabiner

It was found that the carabiner was made of aluminum very slightly alloyed with zinc, magnesium and copper (see spectrogram n°1). Said alloying elements are added to aluminum alloys in order to improve their mechanical strength properties.

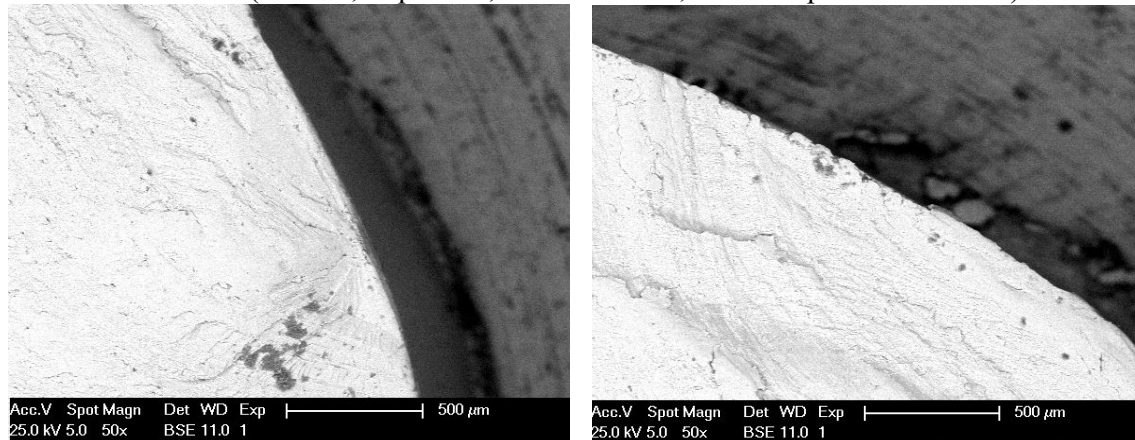
The initiation areas of the fracture were examined in detail, and no significant material defects were found in them (cavities, impurities, internal cracks, etc. - see photos n°4 and 5).

*Photos n°4 and 5 : Two fatigue crack initiation points of carabiner n°1*

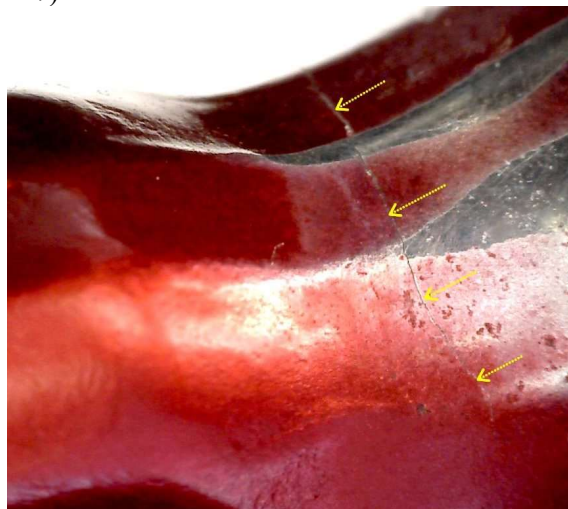
The presence of an initial crack was also found in the same place on the carabiner presented as piece n°2 (photo n°6). From the above findings, it was clear that the occurrence of fatigue fractures in this part of the carabiner (just above the lower bend of the carabiner, on the side opposite the locking mechanism) is not related to any random material defects, but is related to the design of the carabiner. The manufacturer of these carabiners declares their static load capacity of 18 kN in the longitudinal direction and 7 kN in the transverse direction (photo n°7).

*Photo n°6 : The beginning of fatigue fracture on carabiner n°2 in exactly the same places where it was initiated in the case of carabiner n°1*

3. Is there a crack initiation on the second carabiner?
  - There is a crack initiation on the second carabiner in the same area.
4. Does the mechanical wear of the anodized layer affect the strength of the carabiner?

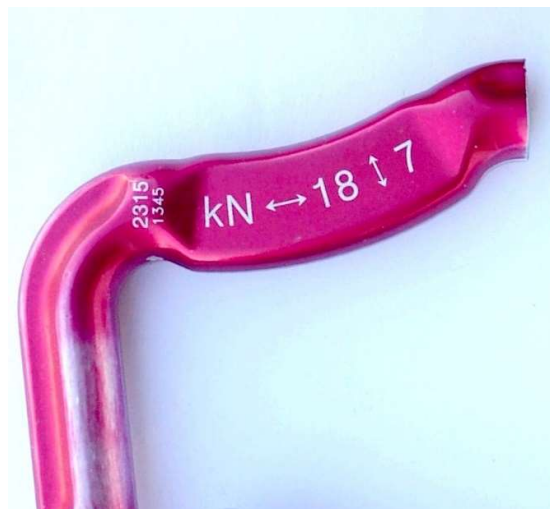
*Photo n°7 : Static loads declared by the carabiner manufacturer in the longitudinal and transverse direction*

The normal operating tensile load of a carabiner should not reach a value of 1 kN for solo flights (nor when considering the oblique direction of the harness straps and the corresponding vector load distribution), which is significantly less than the declared tensile load capacity of the carabiner. Nevertheless, fractures occurred on both carabiners examined. It is known about aluminum and its alloys that it is not possible to precisely determine the so-called “fatigue limit”, as we know e.g. for steel parts. Thus, with the increasing number of

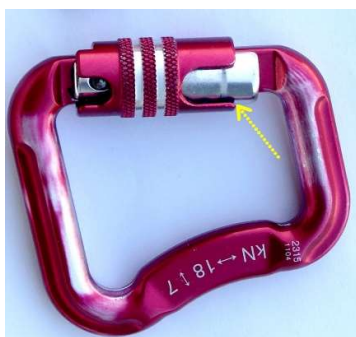
*Photo n°8 : Carabiner n°2 and marked side of the locking mechanism where the grooves and protrusion are located*

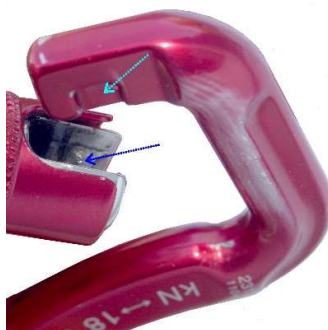
*Photo n°9 : Half-detail of the locking groove and locking lug*

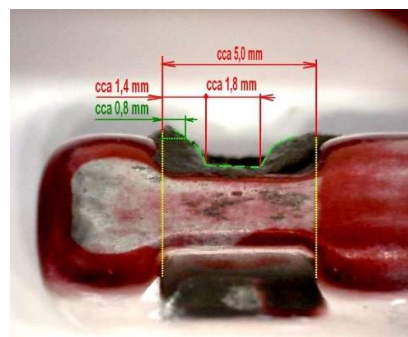
The study was then focused on the working mode of the carabiner in terms of whether it behaves as a closed carrying eye or as an open hook under load. If it were to operate as a closed eye, practically only the axial tensile stress of its bearing cross-section added with a negligible bending stress would act at the fracture location. Another situation would occur if the carabiner worked as an open hook. In such a case, in addition to the axial tension, a significant additional bending stress would also be applied in the damaged area, which could significantly contribute to the proven fatigue damage of the carabiner. In order for the carabiner to behave like an open hook, its locking mechanism (photo n°8) would have excessive gap between the edges of the locking grooves on the fixed part of the carabiner body (groove marked with a light blue arrow in photo n°9) and the contact surface the tilting movable parts of the carabiner (protrusion marked with a dark blue arrow in photo n°9). The approximate value of the gap in this mechanism (in the direction of the applied operating load) was examined on the carabiner n°2 and its value was determined by pressing this locking protrusion in plasticine inserted into one of the locking grooves. Upon subsequent closing and opening of the carabiner in the inserted plasticine, the locking protrusion formed an indentation of a quasi-trapezoidal cross-section with rounded sides (see green dashed line in photo n°10), which was found at the upper edge of the groove, and that this clearance was approximately 0.8 mm (see the green dimension in photo n°10).

*Photo n°10 : Location where the locking lug slides into the locking groove*

It follows from the findings that in the given design of the studied carabiners (material, shape, dimensions, etc.) the main cause of the development of the fatigue damage can be considered excessive clearance gap of their locking mechanisms, which caused excessive additional bending stress of the carabiner in the damaged cross section. The direct connection between the surface treatment of carabiners and the initiation/propagation of fatigue crack on the investigated carabiner has not been proven. Mechanical wear of the anodized layer on the surface of the carabiner has no significant effect on reducing the static load-bearing capacity of the carabiner. It can only be considered as a certain visualization of the extent of operational use of the carabiner. On the carabiner, the manufacturer does not state any restrictions on its usability in terms of the number of flight hours or in terms of the maximum time of use of the carabiner, which, due to the impossibility of determining the so-called fatigue limit on components made of aluminum and its alloys can be considered as a serious deficiency.

- What is the probable cause of the fracture? - Given the carabiner design (material, shape, dimensions, etc.), the main cause of the development of the fatigue mechanism of carabiner damage can be considered excessive clearance gap of the carabiner locking mechanism, as a result of which in addition to tensile stress significant bending stress was applied in the damaged carabiner.
